River Kent and Tributaries SSSI and River Kent SAC

Weirs: Audit and Options Baseline Report

Natural England

April 2015

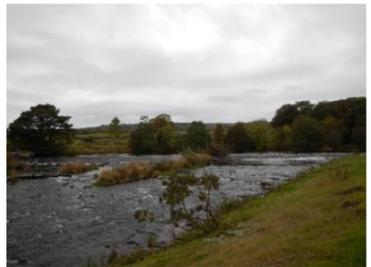
Formal/informal/easement type fish pass	no	mod		Poor condition of weir indicates partial or total collapse is considered likely, which could lead to redundancy of any fish pass installed. Proximity to Scheduled Monument - consent may be required.	mod

View upstream of weir from left hand bank. (SD 51391 90522)

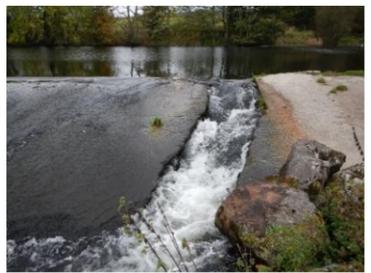
View of fish pass on left hand bank side of weir (SD 51309 90574)

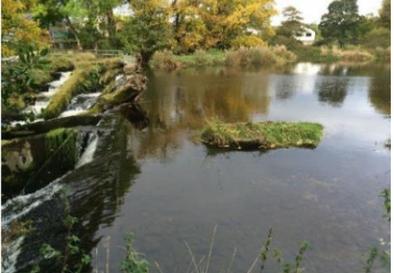
View of weir from left hand bank. (SD 49733 96826)

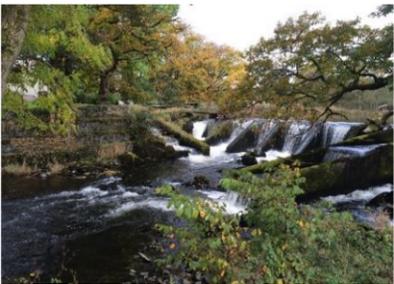
View upstream of weir from left hand bank. (SD 49733 96826)

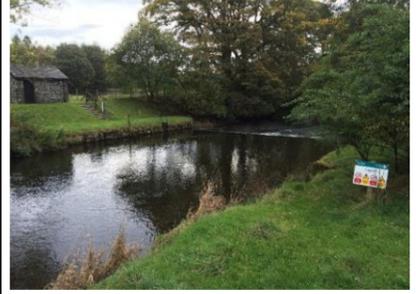
View upstream of weir from right hand bank. (SD 49947 96549)

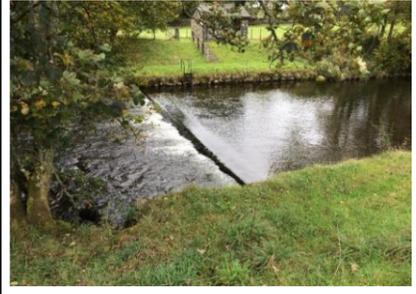
View of weir from left hand bank. (SD 49947 96549)

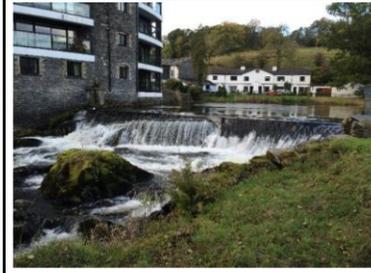
View upstream of weir from left hand bank. (SD 4919897395)

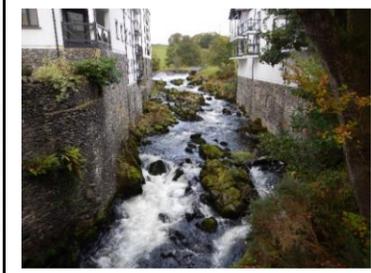
View upstream of weir from footbridge (SD 4928497334)

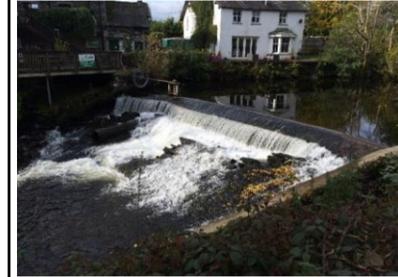
View upstream of weir from left hand bank. (SD 47214 98355)

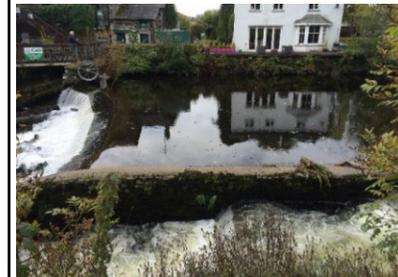
View of weir and fish pass from left hand bank. (SD 47214 98355)

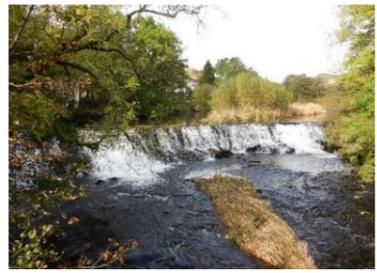
View upstream of weir from right hand bank (SD 47026 98719)

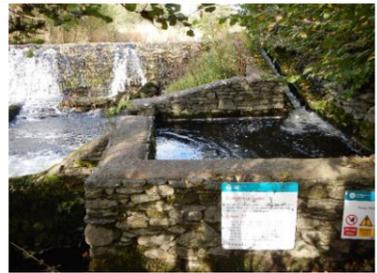
View of Barley Bridge fish pass on left hand bank (SD 47028 98742)

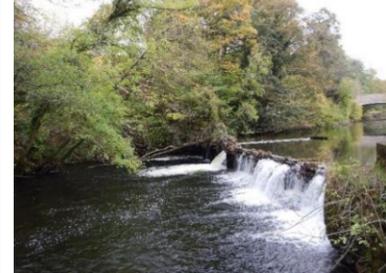
View of weir from left hand bank (SD 54614 95764).

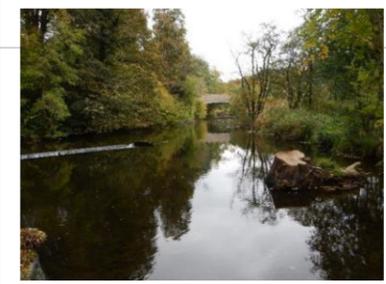
View upstream from weir from left hand bank with aqueduct in distance and fish pass in centre (SD 54622 95764)

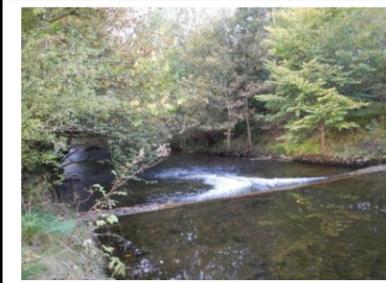
View downstream of weir from left hand bank (SD5148696090).

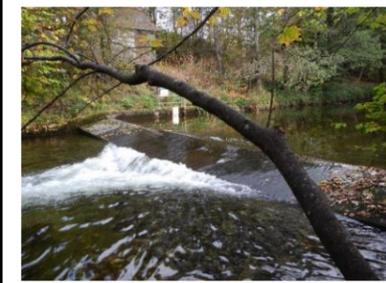
View upstream of weir from left hand bank (SD5147896090).

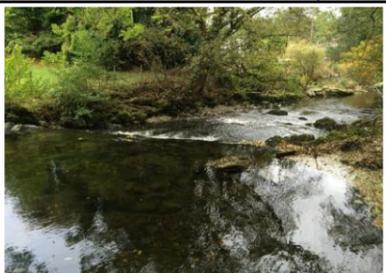
View downstream of weir from right hand bank. (SD 52267 99361)

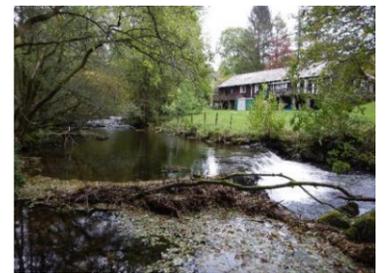
View upstream of weir from left hand bank. (SD 52267 99361)

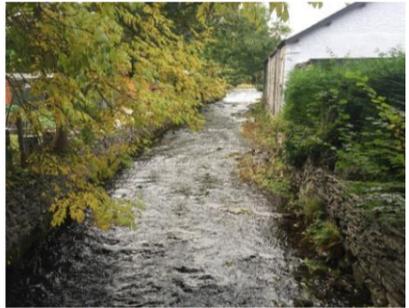
View upstream of weir from bridge (SD 46700 98300).

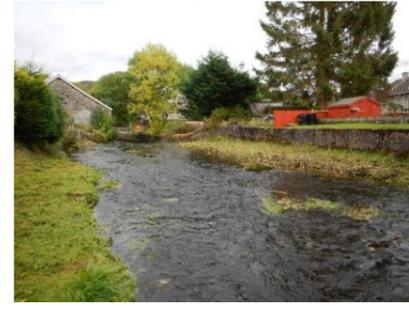
View downstream of weir from left hand bank. (SD 46653 98245)

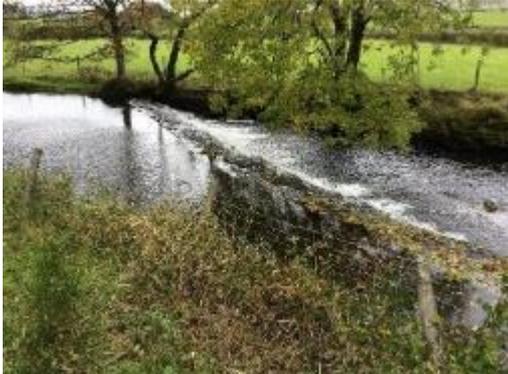
<p>View of weir from right bank</p>

Description	Photograph
<ul style="list-style-type: none"> The joint top ranked option is the full removal of MI03 - weir at Patton Mill and it would result in approximately 9 km of improved habitat connectivity and enhanced migratory potential for all aquatic species (in particular, the removal of a barrier to spawning and local migrations for resident trout and coarse fish). Removal would also directly improve 120 m of currently impounded habitat through improved flow diversity and a return to a riffle-glide sequence. The weir was in good condition at survey, with access available through adjacent farmland and options available for site compound areas. Trees and overhead lines in the vicinity pose manageable constraints to the works, and the removal works are therefore likely to be relatively simple. The geomorphological risk has been assessed as low as the weir is relatively small and in a rural location so the likely impacts of bed adjustment could be easily mitigated.

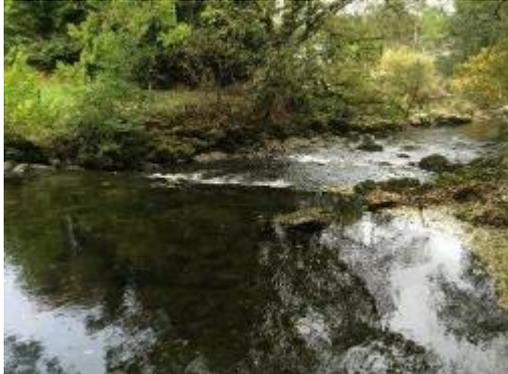
<p>View of weir looking downstream</p>

<ul style="list-style-type: none"> The joint top prioritised option, full removal of SP02 - weir upstream of Garnet Bridge, has moderate ecological and morphological benefits, but high technical feasibility. The weir was in a poor condition at survey with evident defects. Due to its rural location, good access and distance from buildings, it is likely that removal works would be relatively simple subject to access provisions, and would not have significant implications from a flood risk perspective. The removal of the structure would result in approximately 13 km of improved habitat connectivity, improved migratory potential for all aquatic species (in particular, the removal of a barrier to spawning and local migrations for resident trout and coarse fish), and direct improvement of 50 m of currently impounded habitat through improved flow diversity. This site has been assigned a low geomorphological risk based on its more rural location and bedrock channel. Some

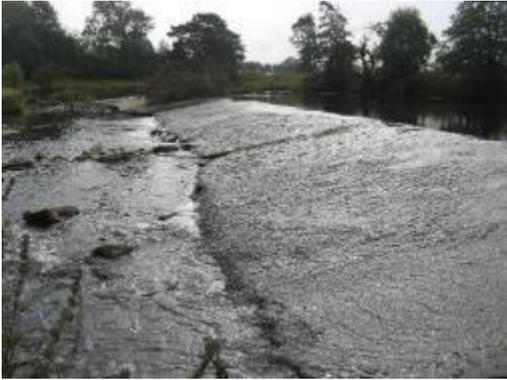
<p>Side view of Helsington Weir</p>

Description	Photograph
<p>lateral adjustment may occur downstream following weir removal to accommodate the increased sediment supply, but there is a low risk to infrastructure and properties. The bedrock also provides a natural bed check limiting upstream erosion.</p>	
<p>For the following three options (KE02, KE08, and KE06,) weir removal is considered to have a high ecological and morphological benefit, with moderate technical feasibility. KE04 and KE07 have moderate ecological and morphological benefits and moderate technical feasibility for full removal and M102 has high benefits but a low feasibility.</p>	
<ul style="list-style-type: none"> • The removal of KE02 – Helsington Weir, Water Crook, would result in approximately 14 km of improved habitat connectivity and enhanced migratory potential for all aquatic species (in particular, the removal of a barrier to spawning and local migrations for coarse fish). • Removal would also directly improve 550 m of currently impounded habitat through improved flow diversity and minor channel migration within an agricultural field setting. • The weir was in poor condition at survey, with major defects (including broken slabs). There was also access and space available for a site compound on the left bank, which would facilitate the removal of the structure. • However, the large weir is immediately downstream of Kendal and holds a vast quantity of sediment behind it. Extensive bed and bank adjustment is likely over a long period of time. There would be a potential need for river training and scour protection and stabilisation works both upstream and downstream. The geomorphological risk of removal at this site is therefore high. • In addition, a more detailed heritage assessment and liaison with the appropriate authorities is likely to be required to ascertain whether this weir needs to be retained for historic landscape reasons.

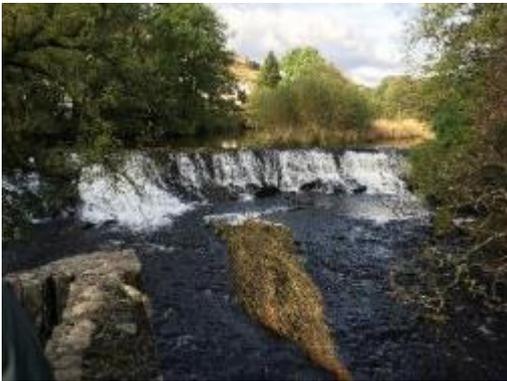
<p>View of the weir</p>

<ul style="list-style-type: none"> • The removal of KE08 – weir at Barley Bridge, Staveley, would result in approximately 15 km of improved habitat connectivity and enhanced migratory potential for all aquatic species (in particular, the removal of a barrier to spawning and local migrations for coarse fish). • Removal would also directly improve 300 m of currently impounded habitat through improved flow diversity, redistribution of channel substrates, and some channel migration on the left hand bank into agricultural land. • The weir was generally in good condition at survey. Access was available from both banks, with space for a site compound on the left hand bank. • Weir removal at this site is considered moderate as the surrounding infrastructure could be at risk as the bed and banks adjust. • Barley Bridge is a listed structure so discussions and a more detailed assessment will be required by the LPA and English Heritage before the weir removal option is progressed.

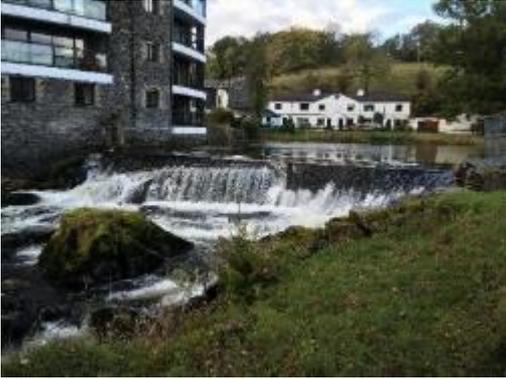
<p data-bbox="935 600 1219 627">View of Cowan Head Weir</p>

Description	Photograph
<ul style="list-style-type: none"> • The removal of KE06 - weir at Cowan Head, would result in approximately 5 km of improved habitat connectivity and enhanced migratory potential for all aquatic species (in particular, the removal of a barrier to spawning and local migrations for coarse fish). • Removal would also directly improve 120 m of currently impounded habitat through improved flow diversity and return of a pool-riffle sequence. • Channel migration would be constrained by bank protection on right hand bank associated with residential properties, but may realign through the left hand bank, associated with a golf course and agricultural fields. • The structure was considered to be in fair condition at survey, with good access through a residential car park on right hand bank or through golf course on left bank as an alternative. Potential site compound areas were also available, located on the edge of the golf course or within the residential development grounds. Overhead power lines on the left hand bank were considered to be a manageable constraint at survey. • The geomorphological risk is deemed moderate at this location due to the risk of adjustment to the residential properties upstream, however, some bedrock was observed in the channel downstream so geomorphological change may be naturally limited. • The one major constraint at this site, as for KE06, is the current abstraction licence.

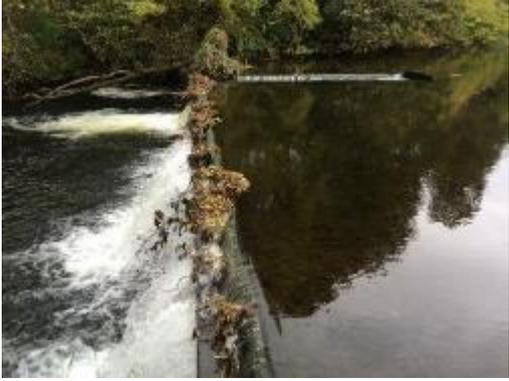
<p data-bbox="933 779 1141 808">View from left bank</p>

Description	Photograph
<p>fairly large and holds a significant quantity of sediment behind it which will be mobilised downstream.</p> <ul style="list-style-type: none"> Perhaps more importantly, certainly in the short-medium term, is the current abstraction licence. It would be extremely costly for the Environment Agency to revoke it as there is no expiry. 	
<ul style="list-style-type: none"> The removal of MI02 – weir upstream of Meal Bank, delivers high ecological and morphological benefits, delivering approximately 16km of improved connectivity if removed although the impact of the structure 100m upstream may be exacerbated. This site however has a low technical feasibility due to limited suitable site compound areas, the need for tree removals to facilitate works, and poor access to the structure. The geomorphological risk of full removal is however considered low at this site.
