REACH ID: **KEN008(1)** SSSI UNIT: **112**

Project Title  
**SSSI RESTORATION (RIVER KENT)**

Drawing Title  
**KENT REACH RESTORATION PLAN**

REACH ID: <b>KEN009(1)</b>	SSSI UNIT: <b>112</b>	
START: <b>349250, 497450</b>	END: <b>351689, 494392</b>

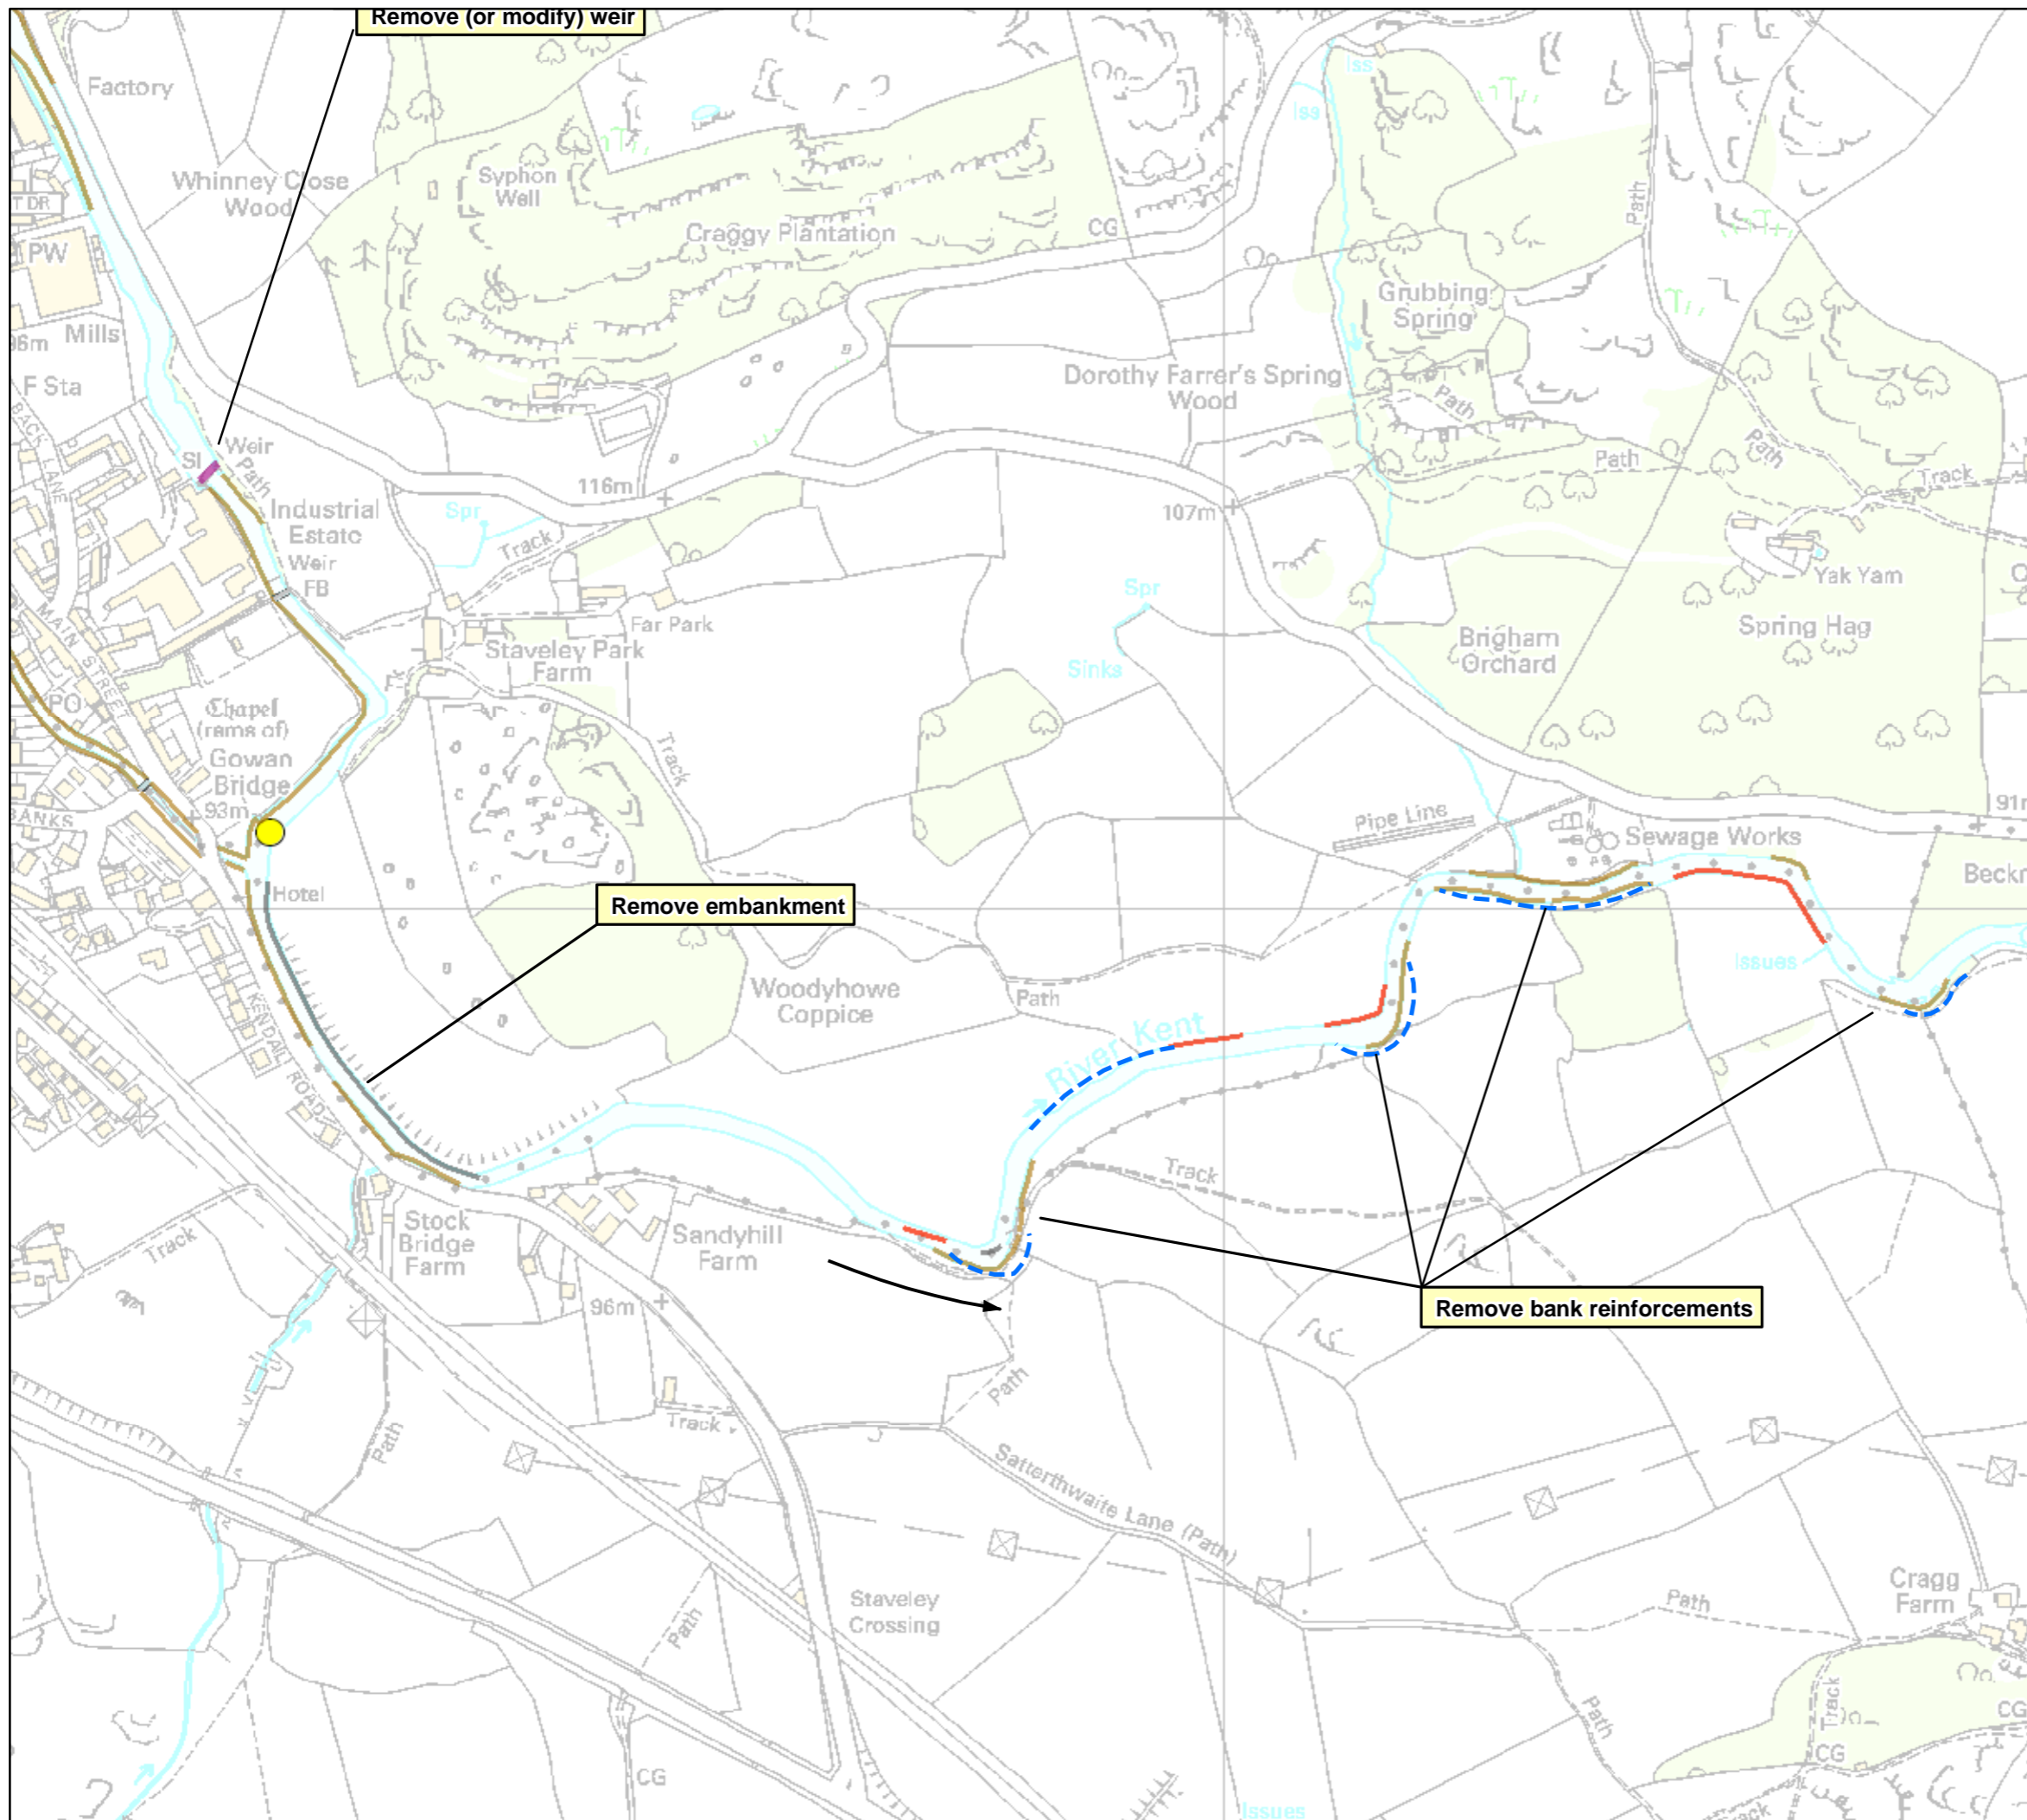
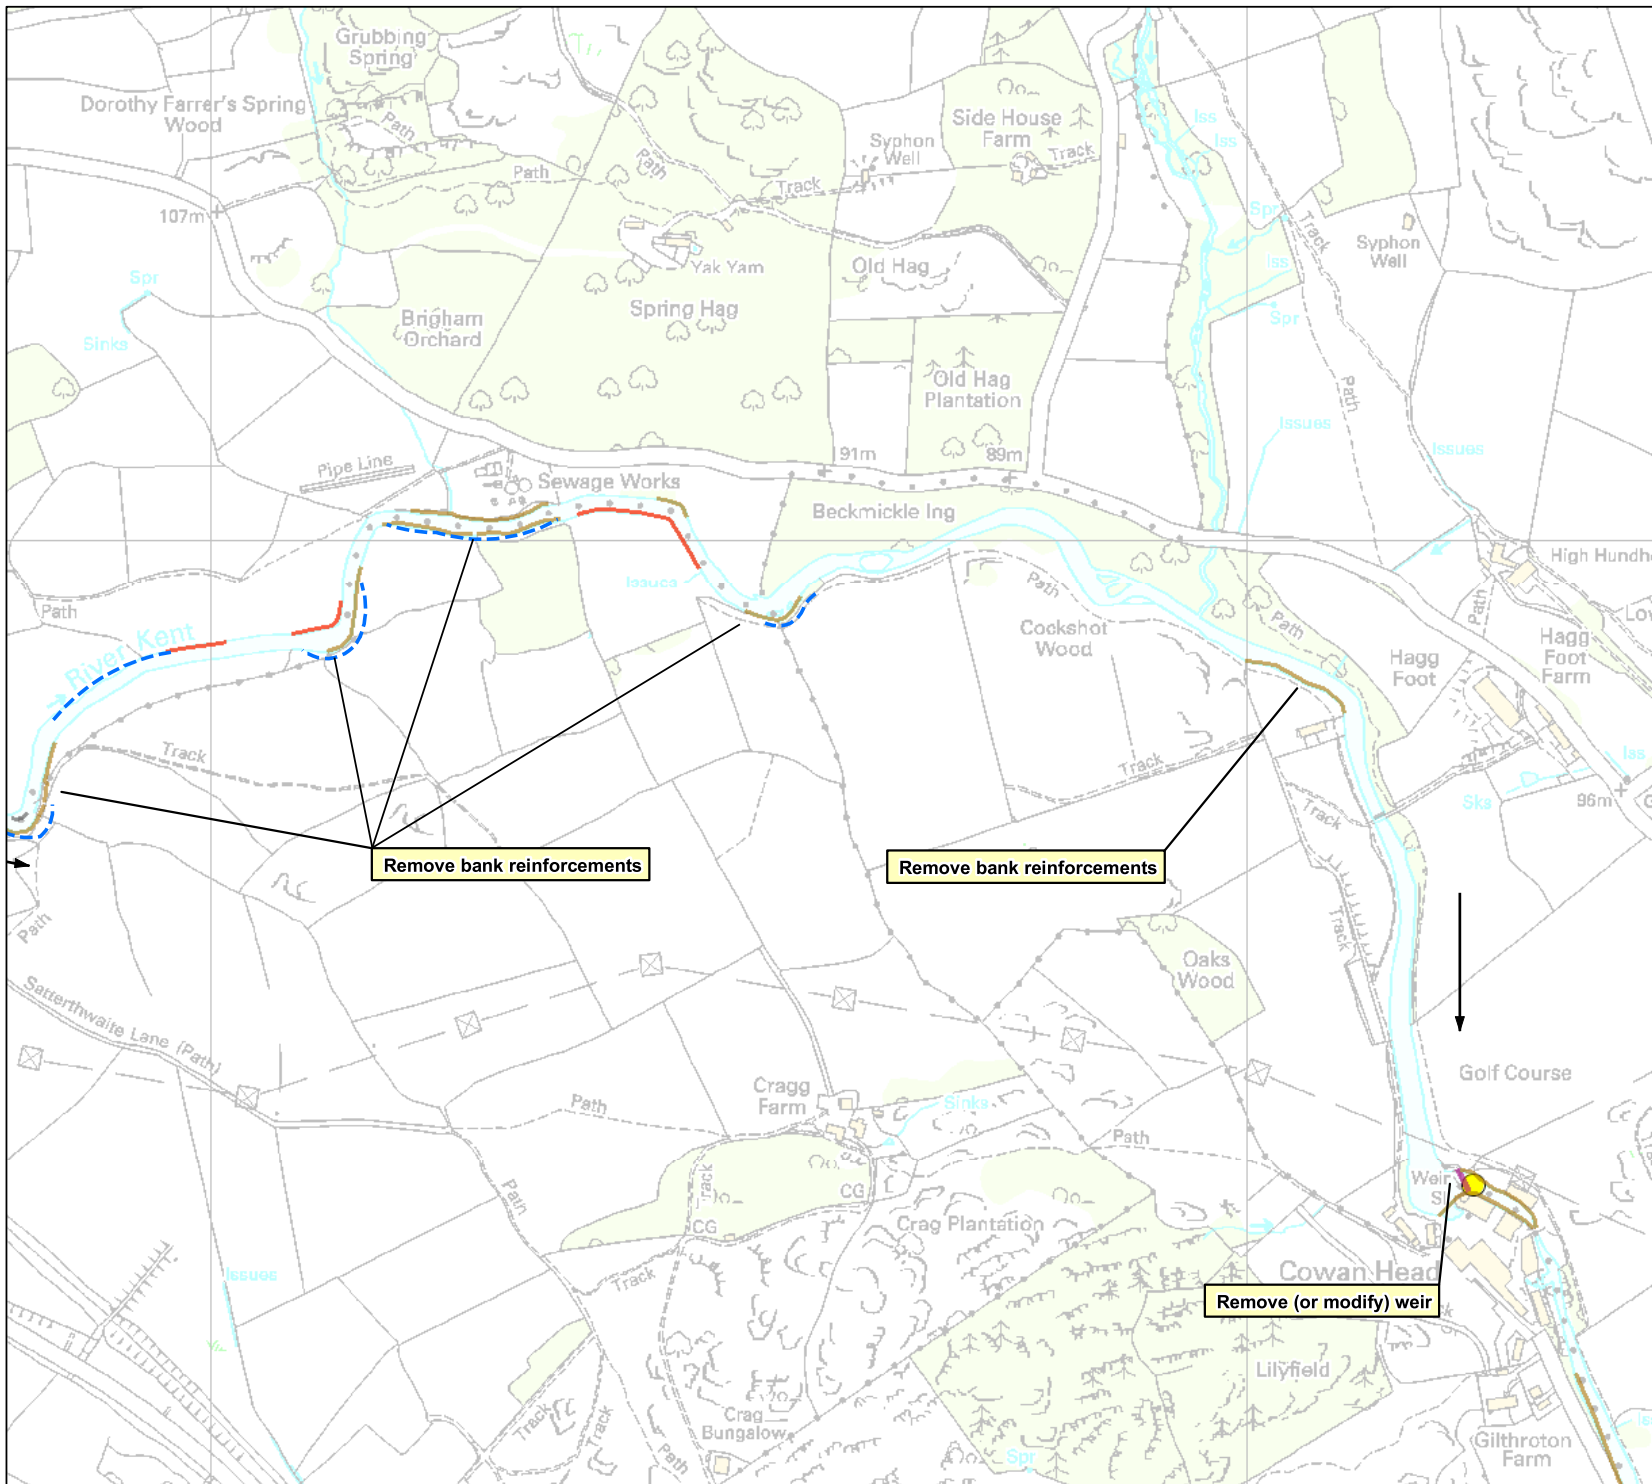
Drawing  
**B1284600/KEN008(1)**

<b>Catchment</b>	Kent	<b>River</b>	River Kent
<b>Reach</b>	KEN008	<b>SSSI Unit</b>	112
<b>Upstream NGR</b>	347250 498060	<b>Downstream NGR</b>	349250 497450
<b>Reach length</b>	3.1 km	<b>Restoration Category</b>	<b>Major Restoration</b>
<b>Geomorphology</b>			
<b>Current State (Pre-restoration)</b>		<b>Benefit (Post-restoration)</b>	
<ul style="list-style-type: none"> <li>• Cobble, gravel river with natural planform</li> <li>• Banks are reinforced and embanked in places (18% and 5% of total bank length respectively)</li> <li>• Some bedrock unmodified sections</li> <li>• Major weir at Cowan Head interrupting sediment transfer and ponded flow</li> <li>• Semi-continuous riparian zone</li> </ul>		<ul style="list-style-type: none"> <li>• Removal or modification of weir will improve natural functioning</li> <li>• Fewer bank reinforcements will promote more lateral adjustment and sediment sourcing and deposition of gravels</li> </ul>

<b>Ecology</b>			
<b>Current State (Pre-restoration)</b>		<b>Benefit (Post-restoration)</b>	
<ul style="list-style-type: none"> <li>• Major weir at downstream end of reach with fish pass</li> <li>• Very isolated salmon spawning (1%) and fry habitats (1%)</li> <li>• Widespread bullhead (66%) habitat</li> <li>• High flows obscuring bed with patches of coarse gravel, cobble and bedrock observed</li> </ul>		<ul style="list-style-type: none"> <li>• Removal of bank protection will lead to an increase in naturalised bank profiles and improve marginal habitats</li> <li>• Despite limited channel adjustment removal of bank reinforcement may create deeper areas on existing meander bends increasing potential fry habitat (5-10%)</li> <li>• Removal/modification of weir will improve fish migration into the upper catchment</li> </ul>	
<b>Constraints and Key Issues</b>			
<ul style="list-style-type: none"> <li>• Weir removal will lead to major channel adjustment, the impacts of which will need to be considered carefully</li> <li>• Some bank reinforcement will have to remain to safeguard properties, infrastructure and the sewage works</li> </ul>

<b>Assumptions and Limitations</b>			
<p><b>Riparian Zone Management</b>  Unless otherwise indicated, the riparian zone should be fenced off along both banks of the river to enable the riparian zone to recover through natural vegetation colonisation. The fence should be placed a minimum of 5 metres from the bank top along straight sections of channel and on the inside of bends. Around the outside bank of bends in the river the fence should be sited a minimum of 10 metres from the bank top.</p> <p><b>Channel adjustment</b>  Zone of channel adjustment is based on professional judgement and field interpretation only with no site specific detailed assessment.</p>

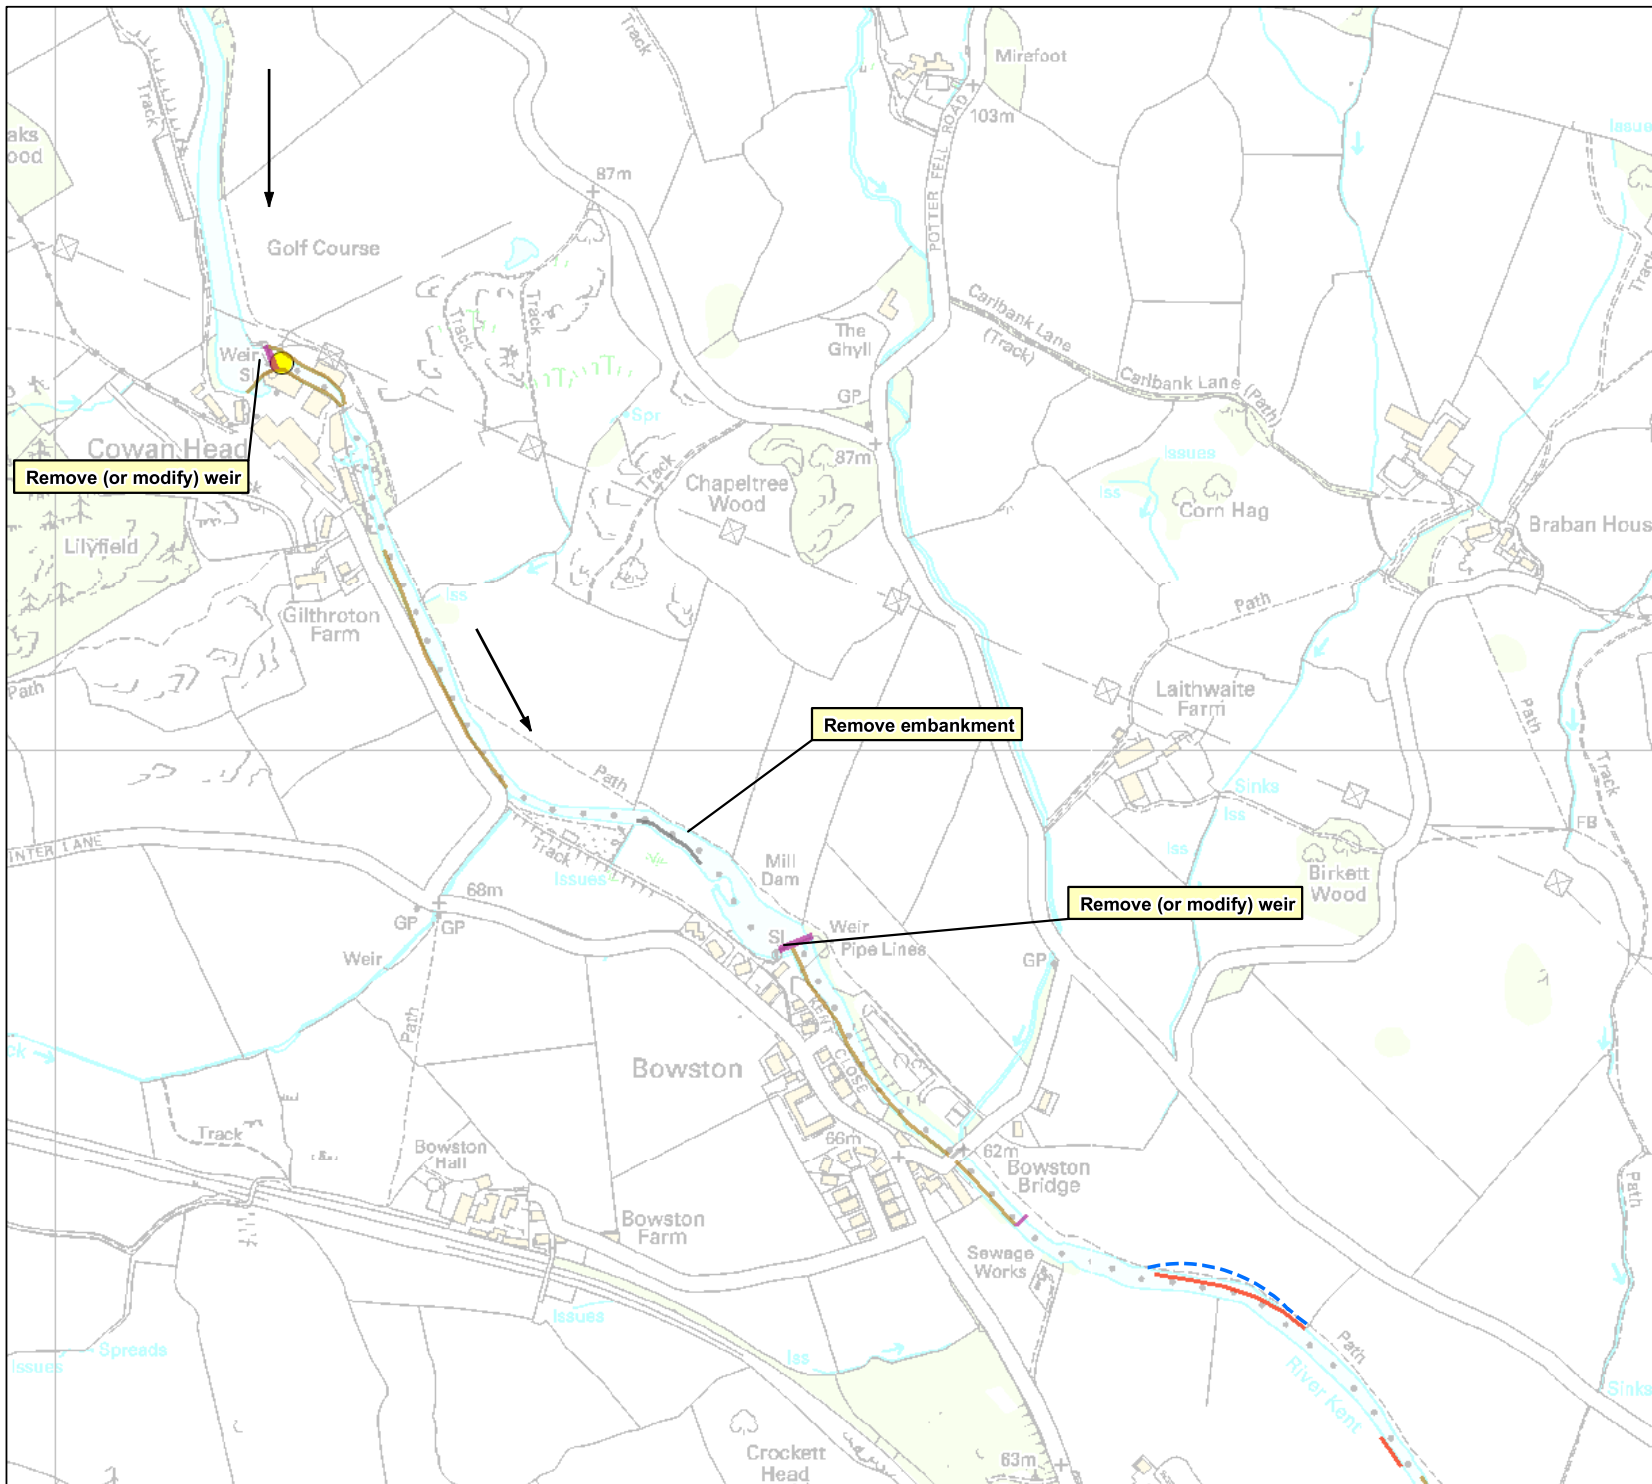
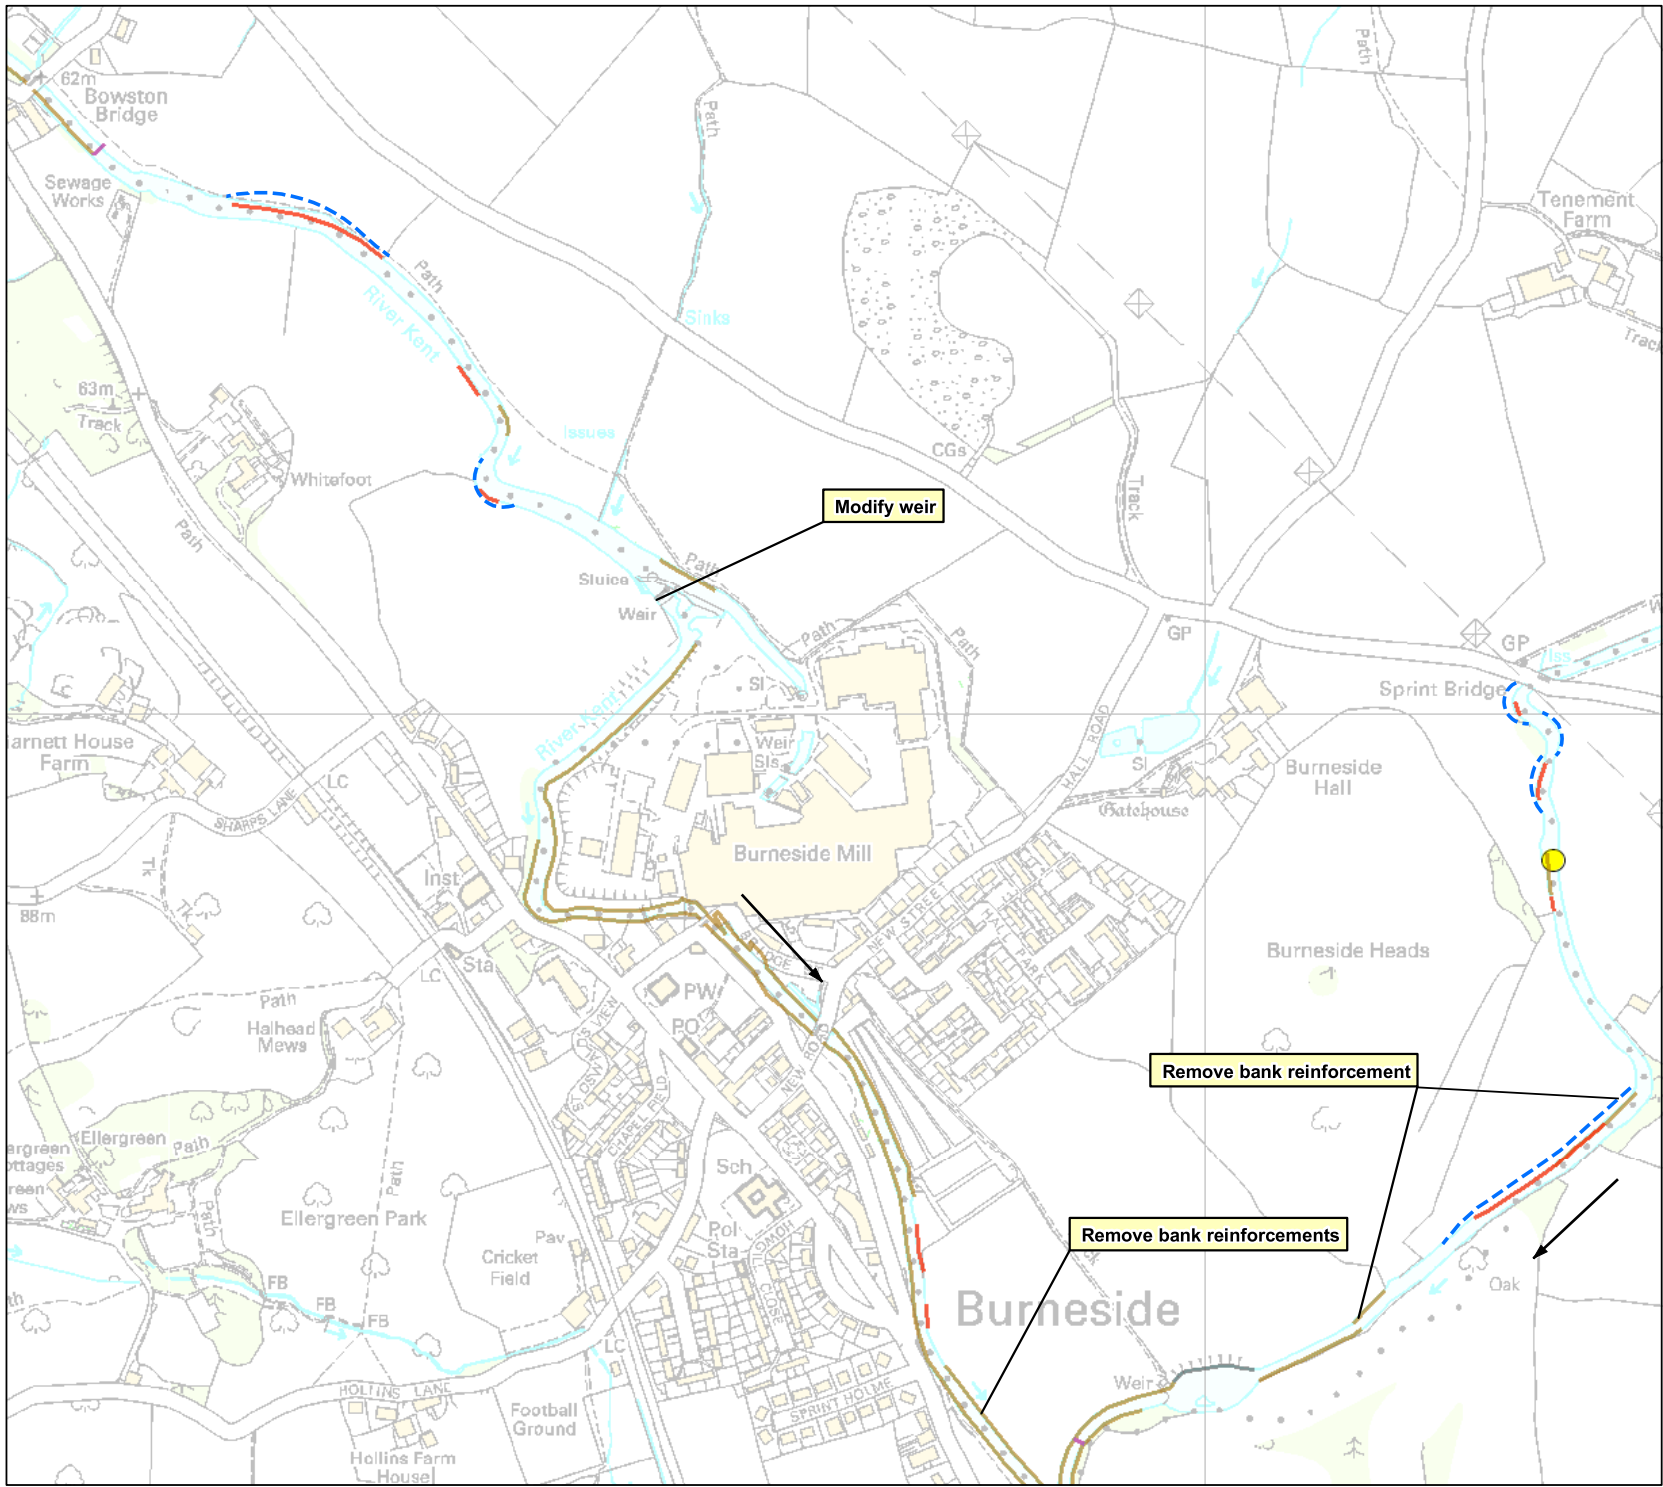
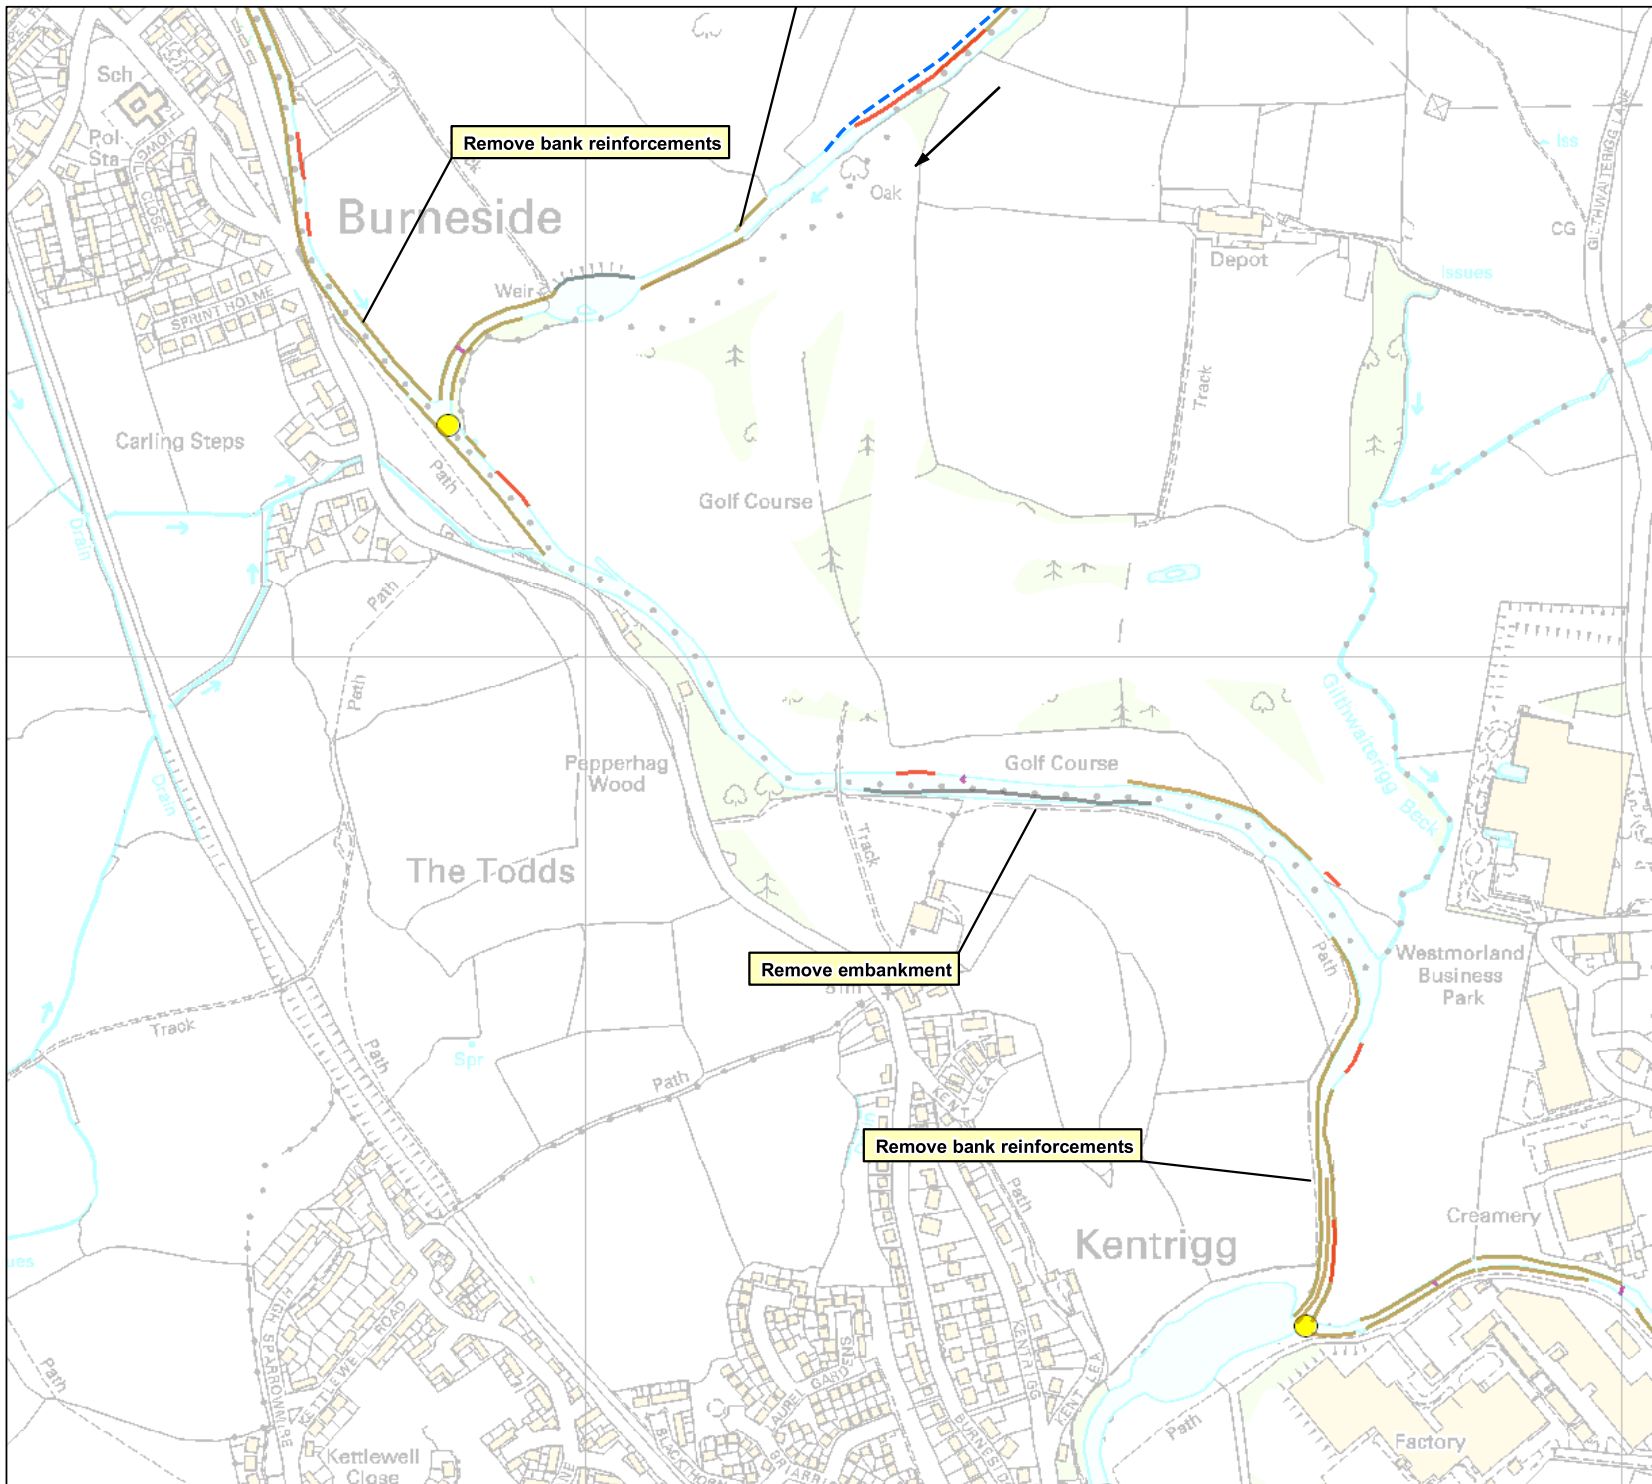
Drawing: **B1284600/KEN009(3)**

<b>Catchment</b>	Kent	<b>River</b>	River Kent
<b>Reach</b>	KEN009	<b>SSSI Unit</b>	112
<b>Upstream NGR</b>	349250 497450	<b>Downstream NGR</b>	351689 494392
<b>Reach length</b>	4.7 km	<b>Restoration Category</b>	<b>Major Restoration</b>
<b>Geomorphology</b>			
<b>Current State (Pre-restoration)</b>		<b>Benefit (Post-restoration)</b>	
<ul style="list-style-type: none"> <li>The channel has been modified through the use of weirs and mills and in the vicinity of urban development</li> <li>Bank protection totals approximately 40% of total bank length, some reinforcement is failing</li> <li>Weirs at Bowston and Burneside disrupt sediment transfer and pond flow</li> <li>More natural channel downstream of Burneside showing erosion and deposition features</li> </ul>		<ul style="list-style-type: none"> <li>Natural recovery can be assisted where bank reinforcements can be removed</li> <li>Removal or modification of the weirs will aid sediment transfer and improve flow diversity upstream</li> </ul>

<b>Ecology</b>			
<b>Current State (Pre-restoration)</b>		<b>Benefit (Post-restoration)</b>	
<ul style="list-style-type: none"> <li>High run flows (49%) obscuring bed composition</li> <li>Emergent vegetation observed in marginal stands along watercourse</li> <li>Large numbers of fry seen in slack behind downstream cobble point bar</li> <li>Suitable habitat for salmon parr (20%), bullhead (56%) and crayfish (52%) with very isolated substrates supporting salmon spawning (1%)</li> </ul>		<ul style="list-style-type: none"> <li>Removal of bank protection will lead to an increase in naturalised bank profiles and improve marginal habitats for crayfish (20% increase in suitable habitat)</li> <li>Minimal channel adjustment post restoration will not significantly increase in-channel habitat suitability</li> <li>Assessment of fish pass success may identify improvements that open up the upper catchment under a greater variety of flow conditions</li> </ul>

<b>Constraints and Key Issues</b>			
<ul style="list-style-type: none"> <li>Modification or removal of major weirs will lead to channel adjustment and the impacts need to be carefully considered.</li> <li>Allowing lateral adjustment may result in land use issues.</li> <li>Infrastructure and properties need to be protected (urban constraints).</li> </ul>			
<b>Assumptions and Limitations</b>			
<p><b>Riparian Zone Management</b>  Unless otherwise indicated, the riparian zone should be fenced off along both banks of the river to enable the riparian zone to recover through natural vegetation colonisation. The fence should be placed a minimum of 5 metres from the bank top along straight sections of channel and on the inside of bends. Around the outside bank of bends in the river the fence should be sited a minimum of 10 metres from the bank top.</p> <p><b>Channel adjustment</b>  Zone of channel adjustment is based on professional judgement and field interpretation only with no site specific detailed assessment.</p>
