WEIR'S IT GONE? ENNERDALE MILL DAM: CONCEPT TO DESTRUCTION

Ennerdale Mill Dam Weir

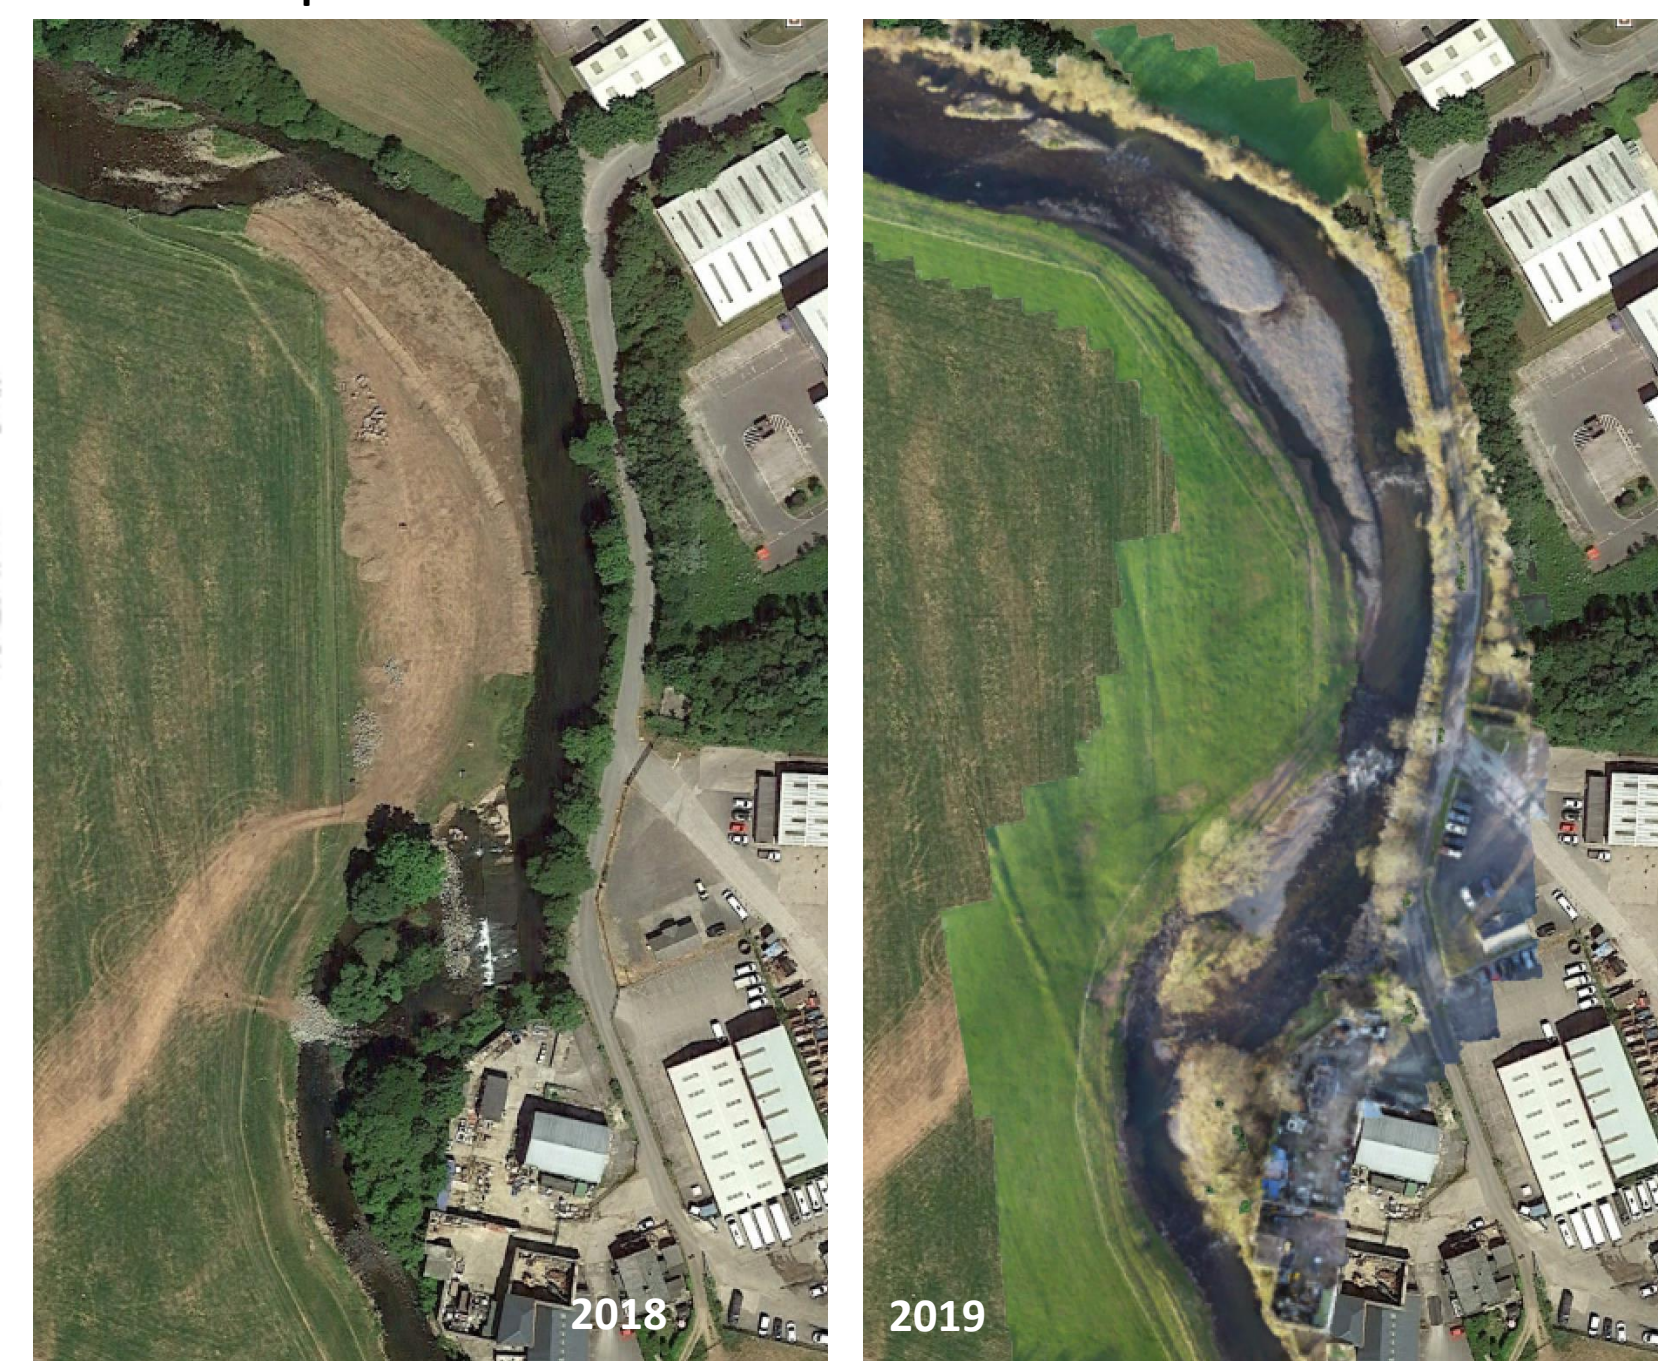
Works included partial removal of the weir along the centre and right of the channel, repairs to the failed right bank weir walling, boulder blockstone revetment around the remnant weir to ensure stability, retention of the sluice structure to enhance the heritage value of the site, extension of the right bank protection to include all of the access road where it parallels the watercourse, bed excavation and creation of a boulder rapid at the old weir site linking with the extant rapid feature downstream, creation of a second smaller boulder rapid between the old weir and the transvers bar feature upstream and the excavation of an inset berm/point bar on the right bank to reduce flood erosion pressure on the left bank infrastructure.

The principal features remain dynamically stable at the site with fish passage now fully restored. An inner bend chute channel is developing across the point bar which is likely to convert this to a transverse bar feature over time. No changes have been observed to the channel downstream with all fishing pools remaining. Upstream erosion of the right bank persists but this is unrelated to the removal.

Final option for Ennerdale Mill Weir and before and after orthophoto of the local site.
